DRAFT
FEDERAL ON-SCENE COORDINATOR'S REPORT FOR
THE WINDHAM ALLOYS SITE
WINDHAM, PORTAGE COUNTY, OHIO
SITE ID: B5E5
TDD: S05-0003-011
PAN: 0M1101RAXX
START DOCUMENT CONTROL NUMBER:

SUBJECT: ON-SCENE COORDINATOR REPORT- Windham Alloys Site, Windham, Portage County, Ohio, Site ID# B5E5

Removal Dates: 3/13/00 - 6/29/00

EXECUTIVE SUMMARY OF REMOVAL ACTIVITY

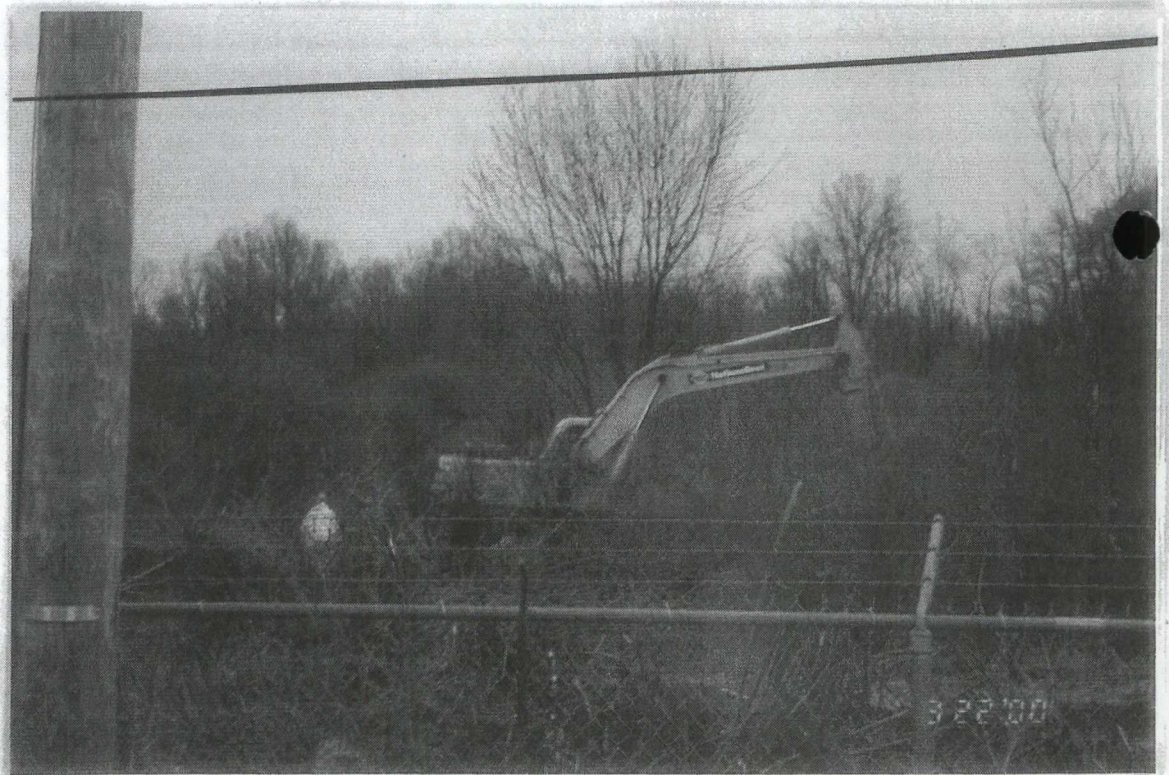
Description: This photograph shows the ERRS crew clearing area for test trench excavations.

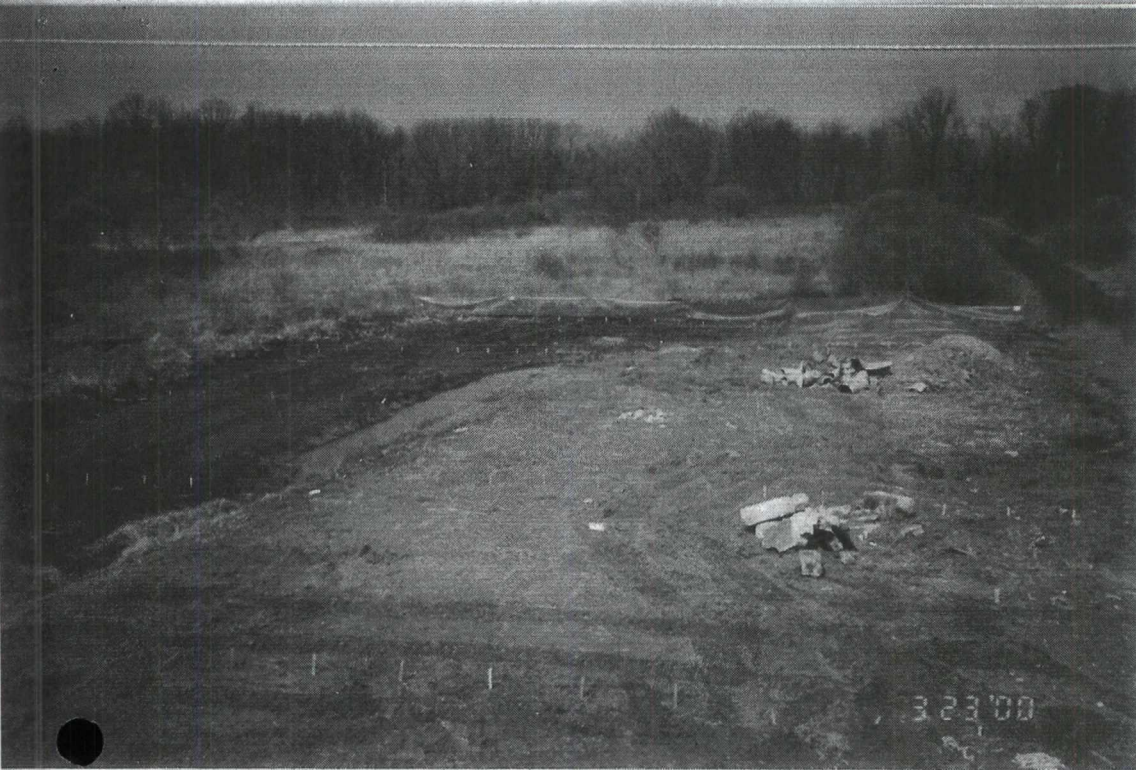
Description: Overview of the main excavation area taken from an on-site manlift.

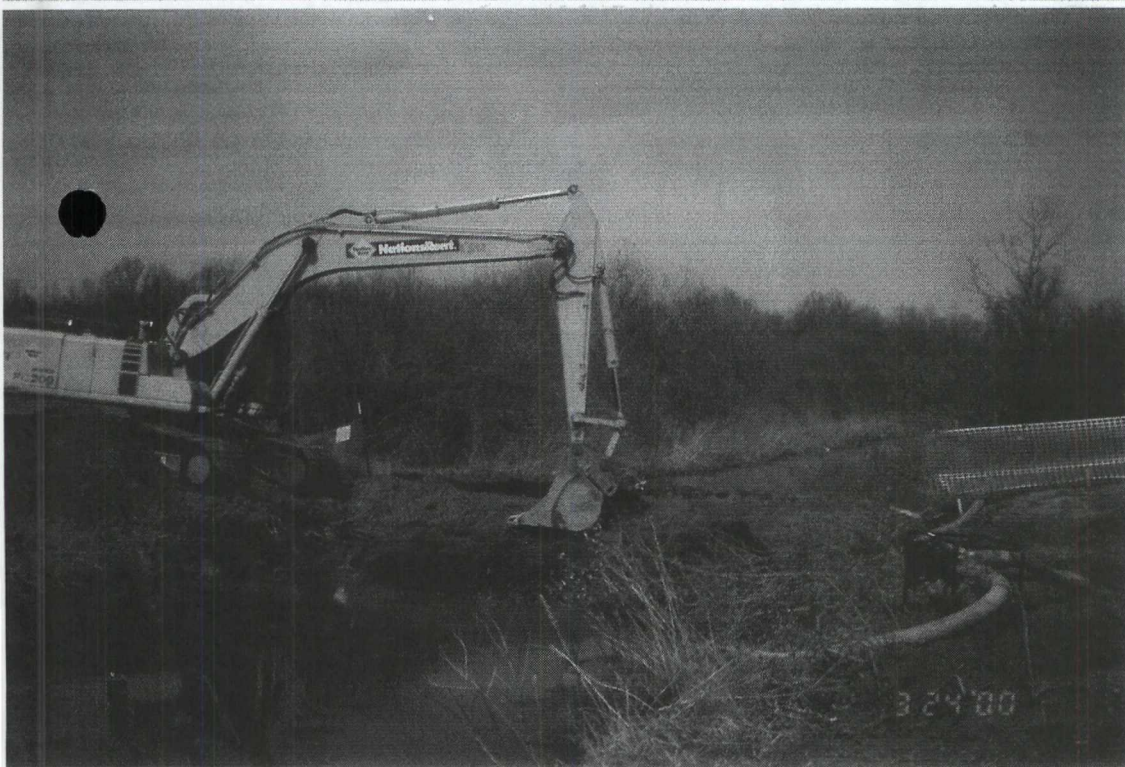
Description: This photograph shows the ERRS crew constructing an earthen dam in the main excavation area.

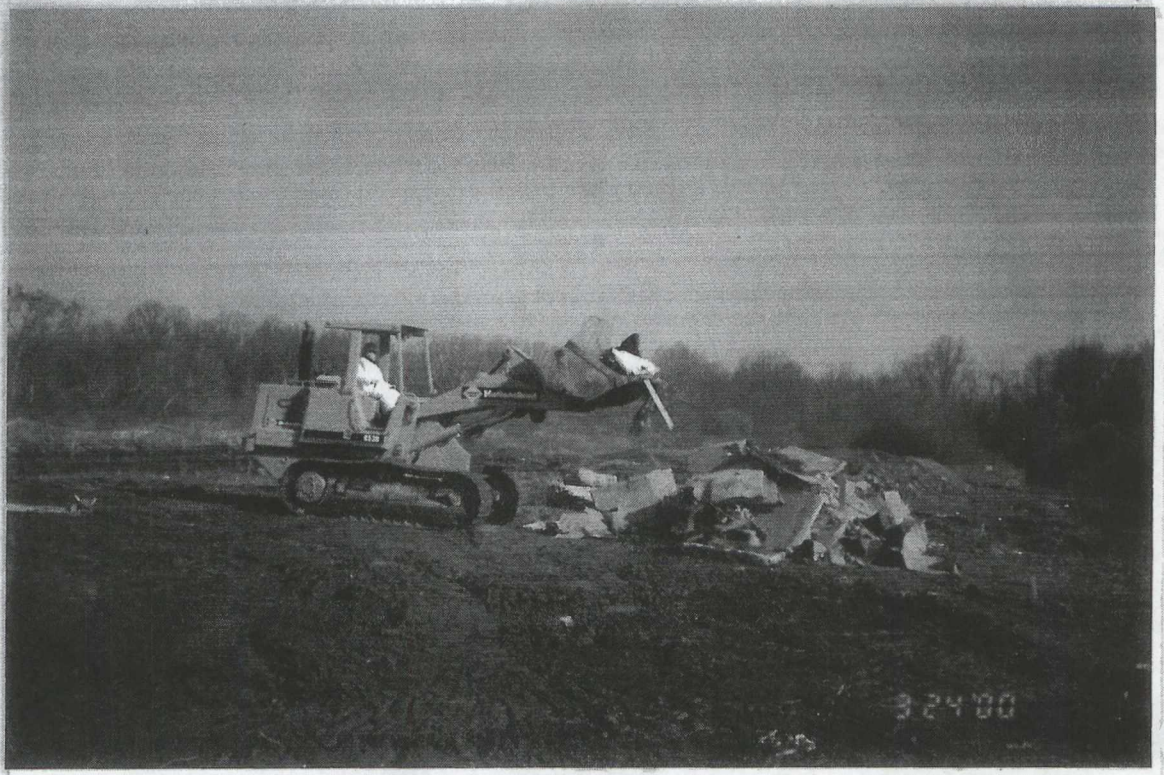
Photo: 5

Description: This photograph shows the ERRS crew moving solid nonhazardous debris from the exclusion zone into roll-off boxes for transportation off-site for final disposal.

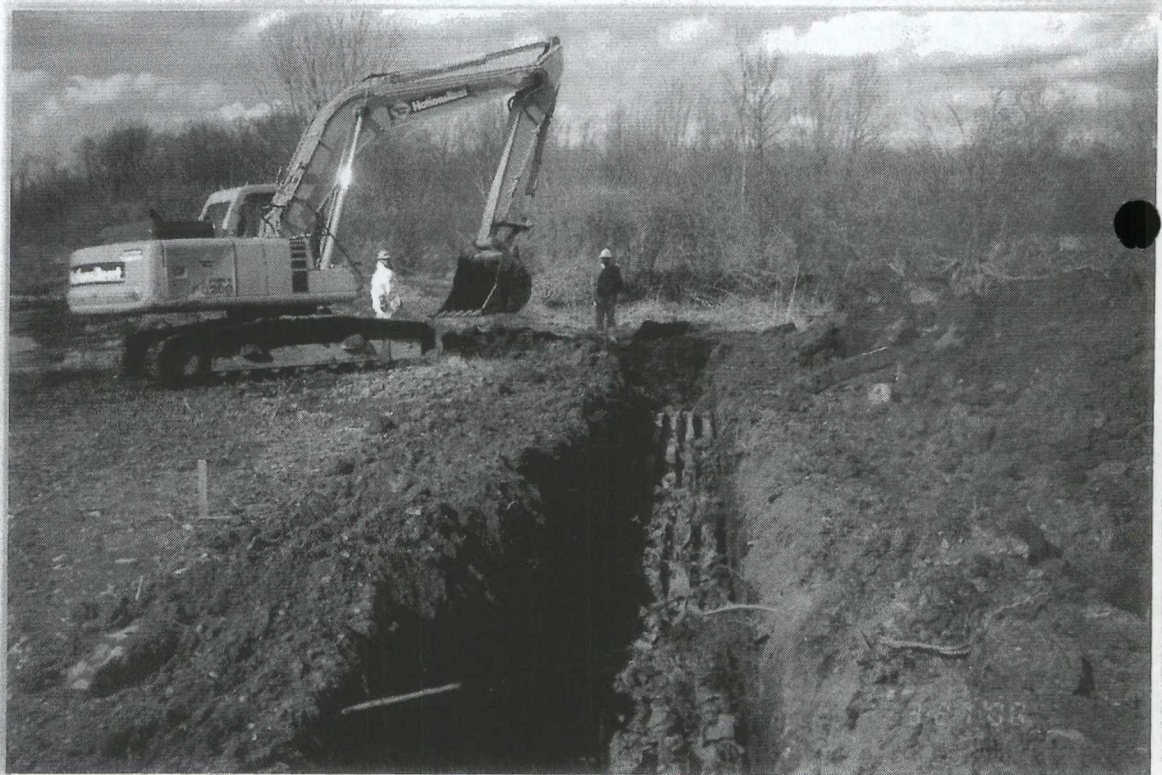
Photo: 6

Description: This photograph shows the test trench dug in the eastern excavation area to evaluate potentially impacted areas.

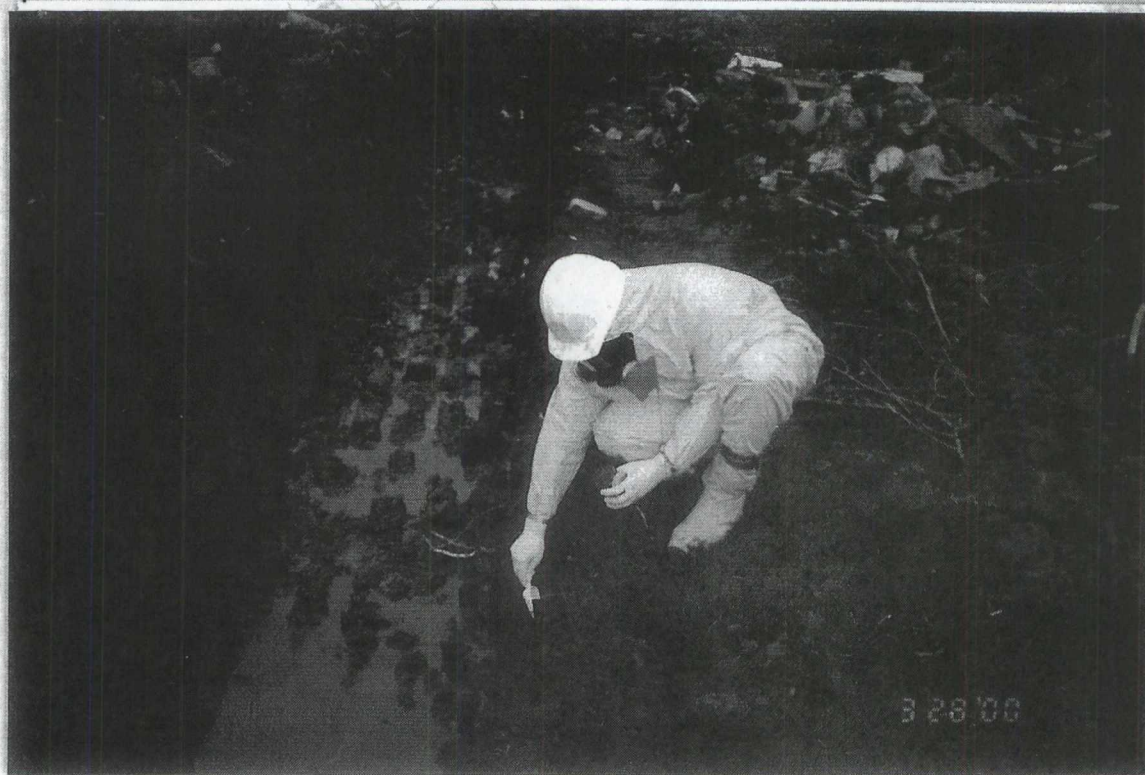
Description: This photograph show START collecting a grab sample from a test trench in the main excavation area. The sample was screened using an X-ray fluorescence (XRF) unit for chromium and lead levels.

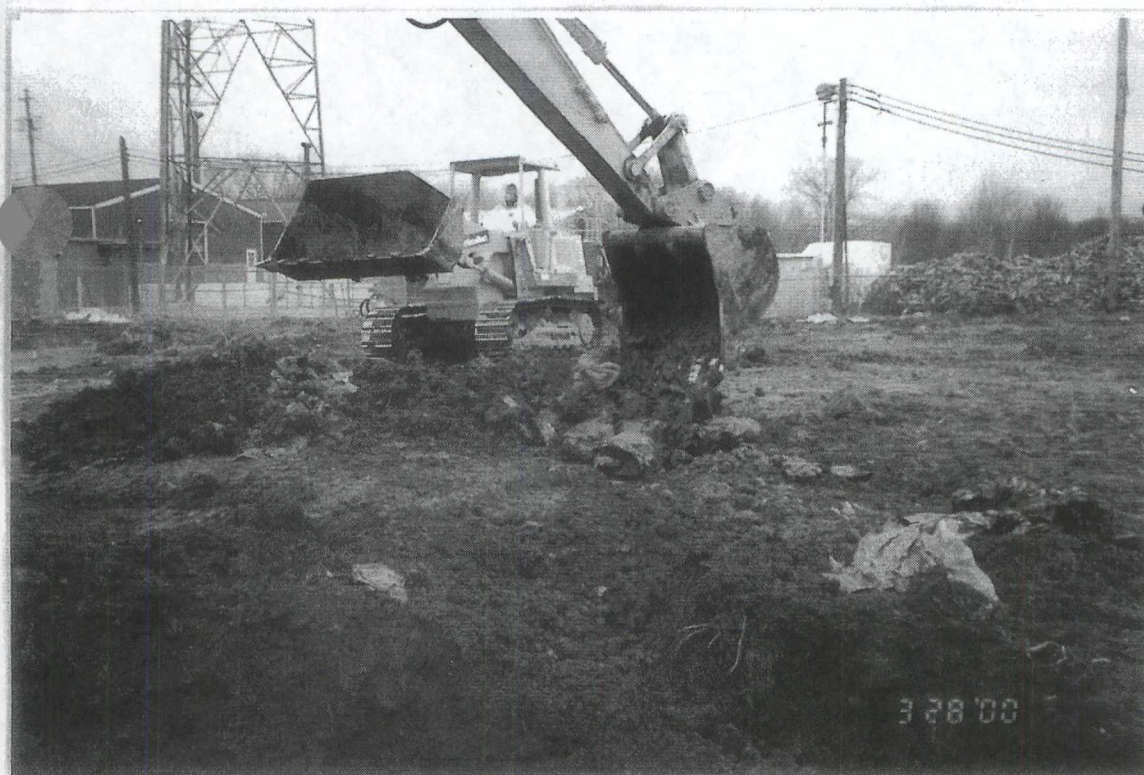
Description: This photograph shows the ERRS crew starting excavation of the main excavation area. Note the crushed drums near the excavator bucket.

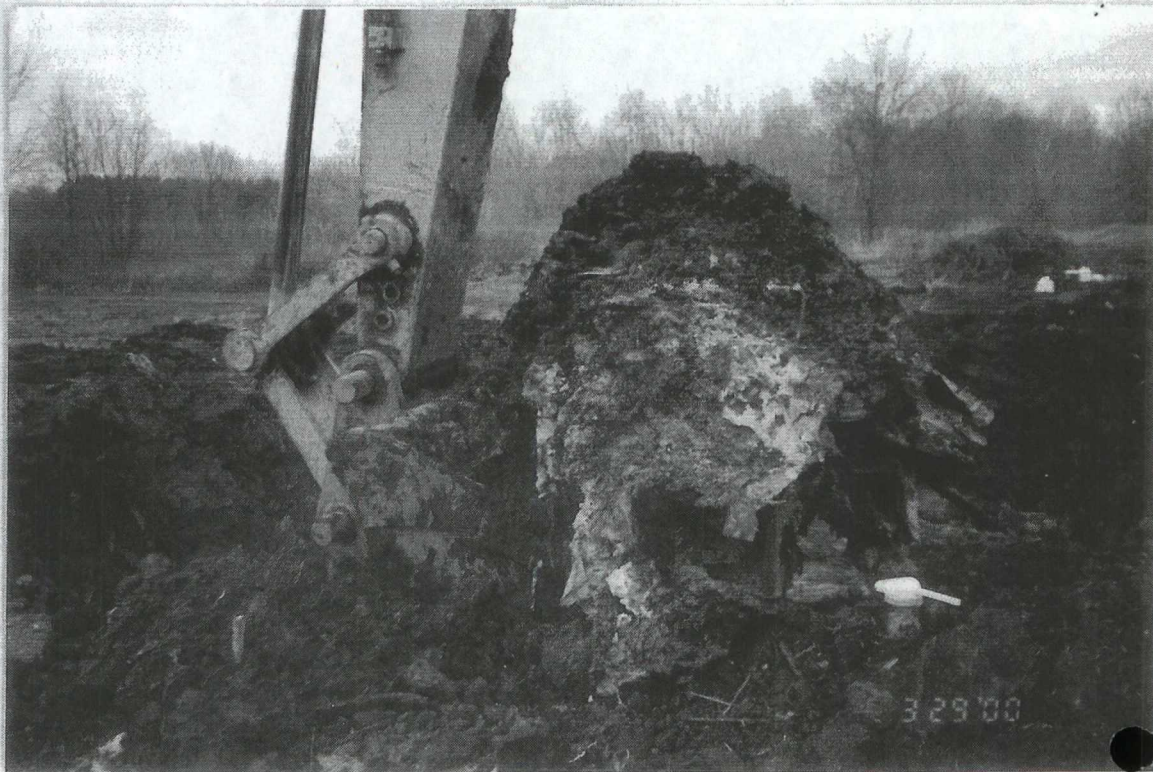
Description: This photograph shows waste removed from the main excavation area.

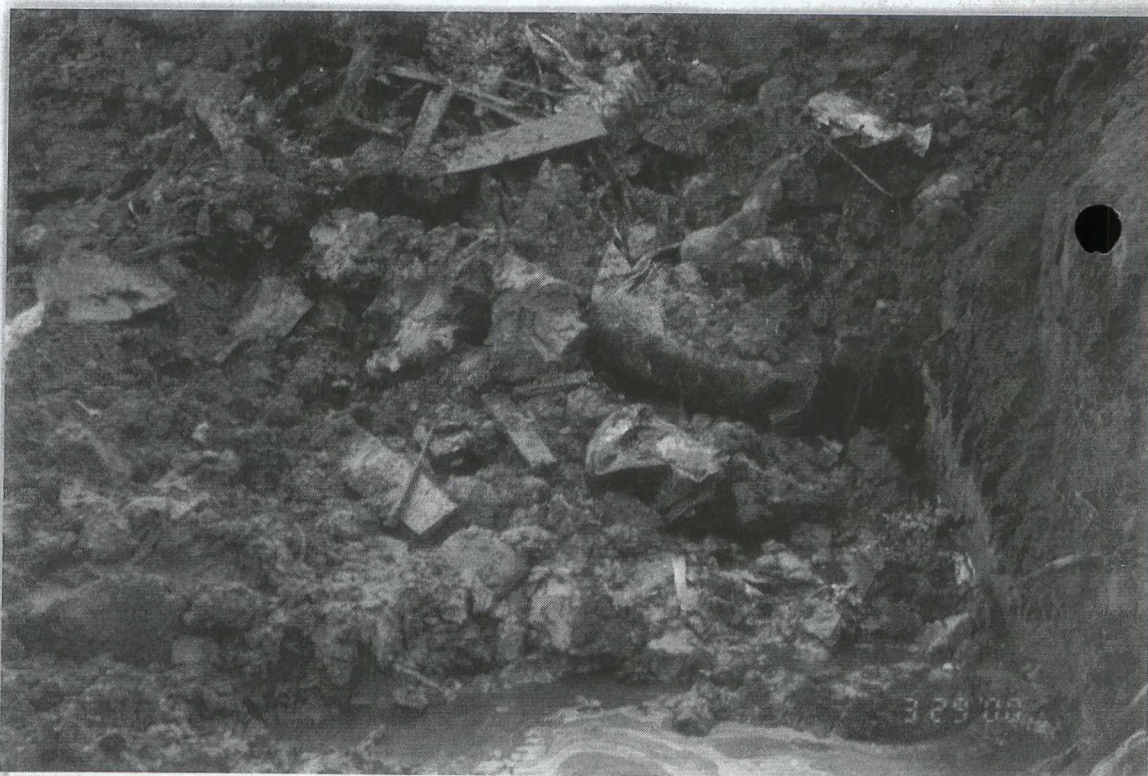
Description: View of solid waste located in the main excavation pit.

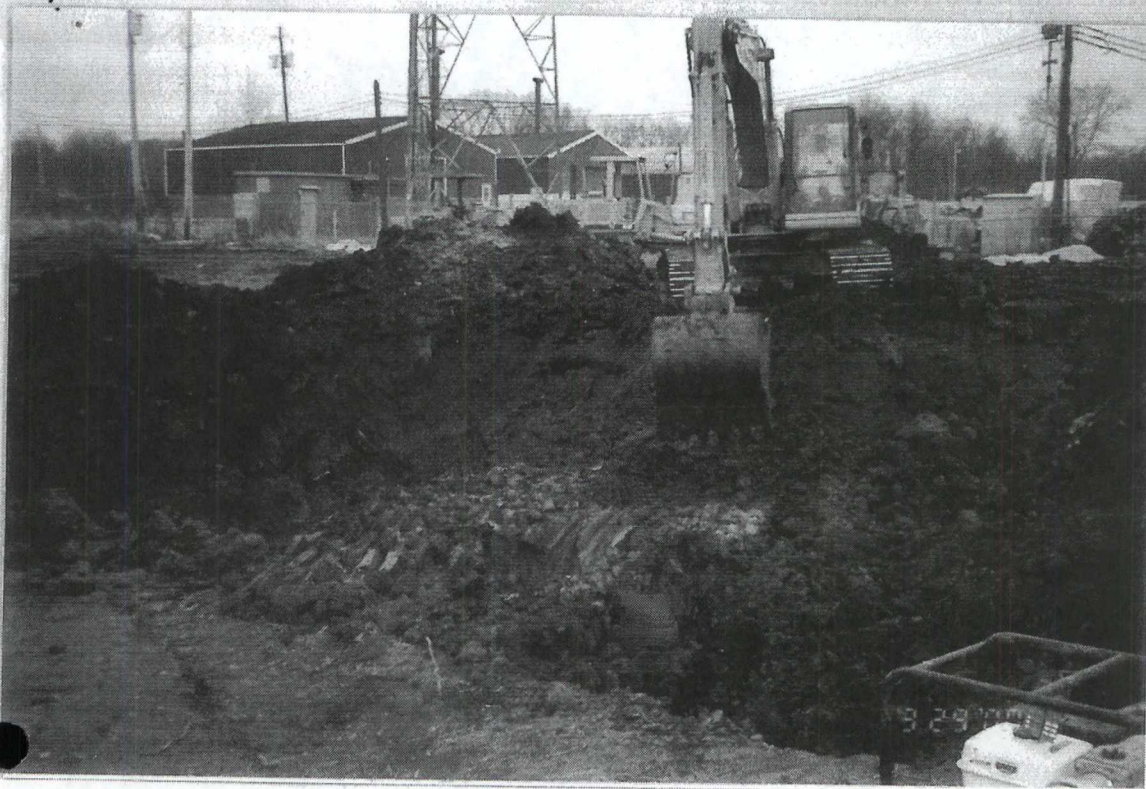
Description: This photograph shows the excavation pit located in the main excavation area.

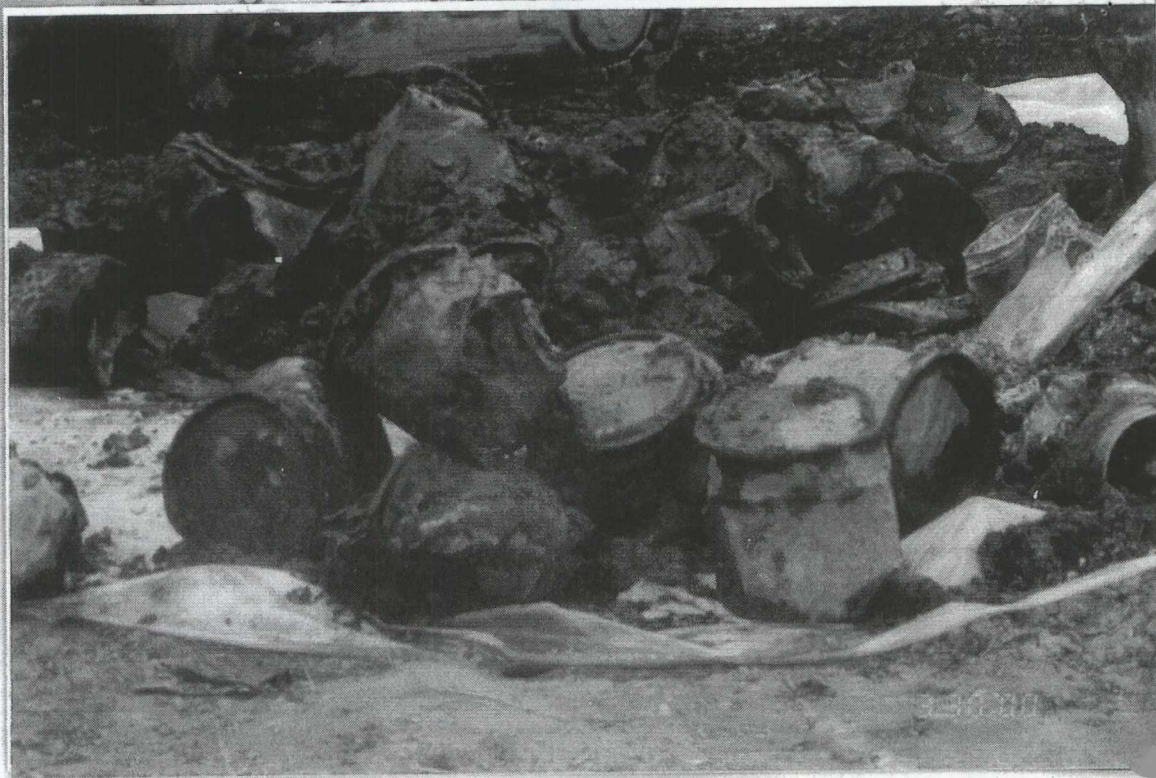
Description: This photograph shows the containers collected from the main excavation area.

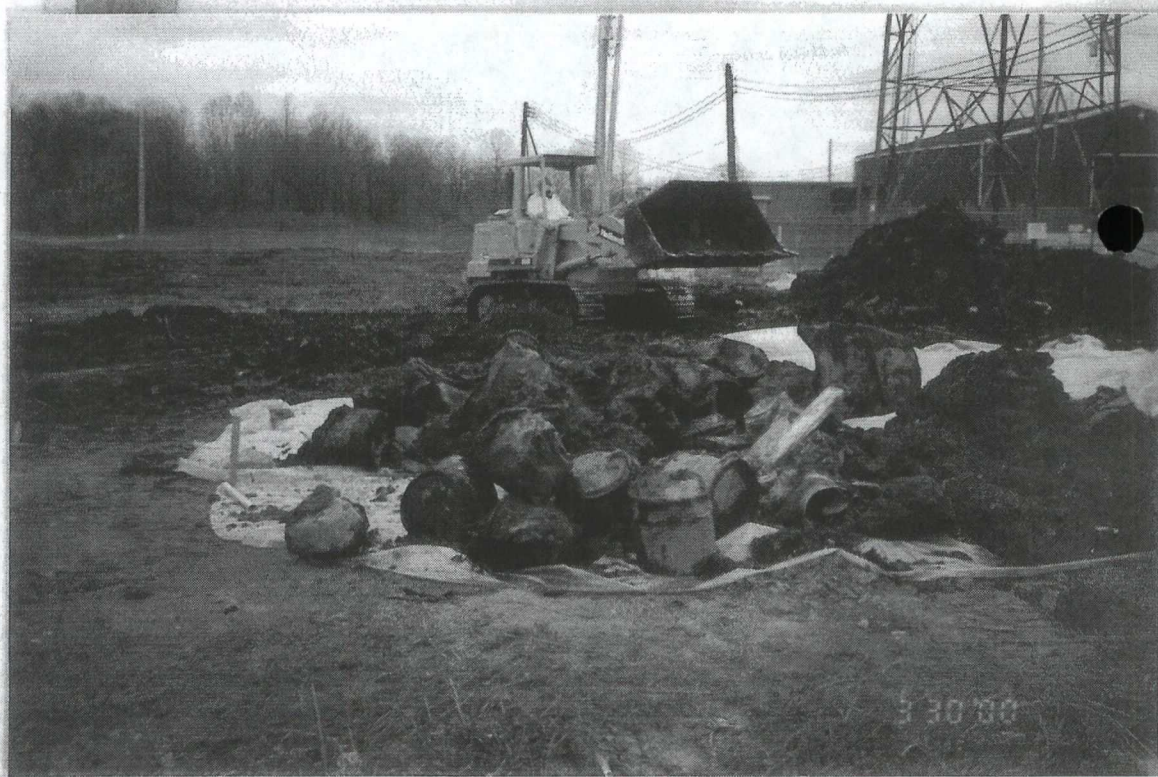
Description: This photograph shows staged drums collected from the main excavation area.

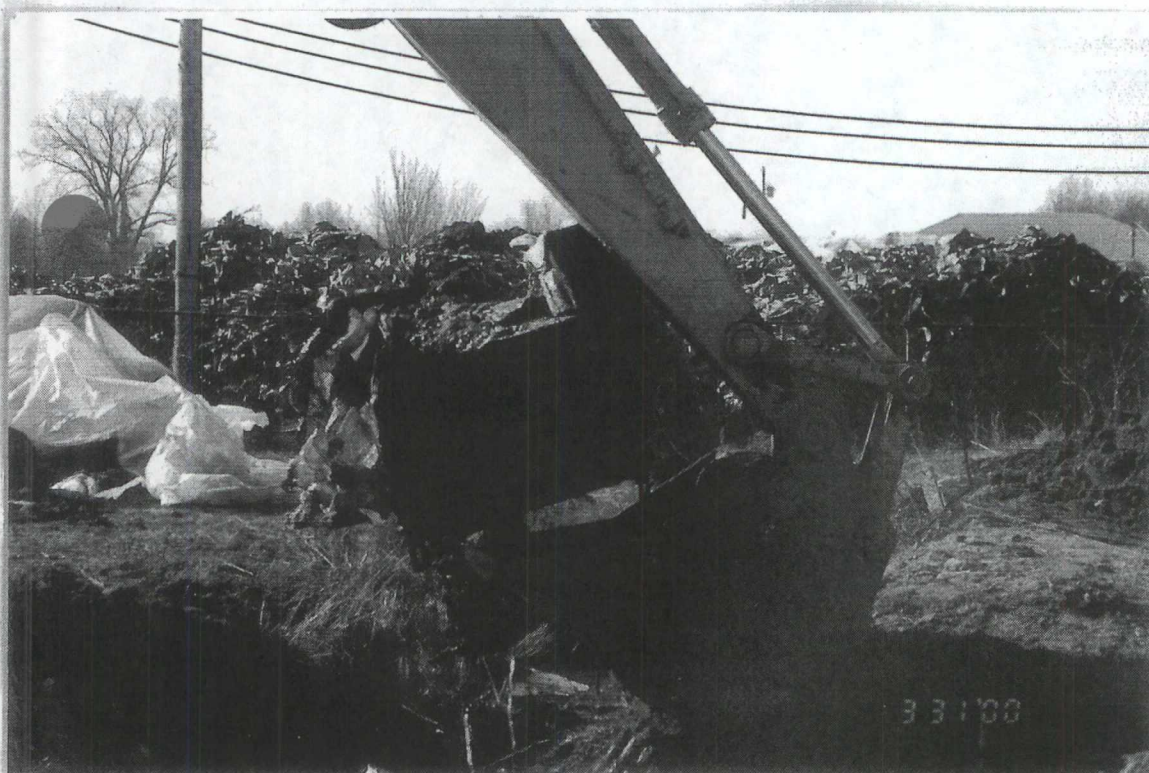
Description: This photograph shows a metal bin removed from the main excavation area.

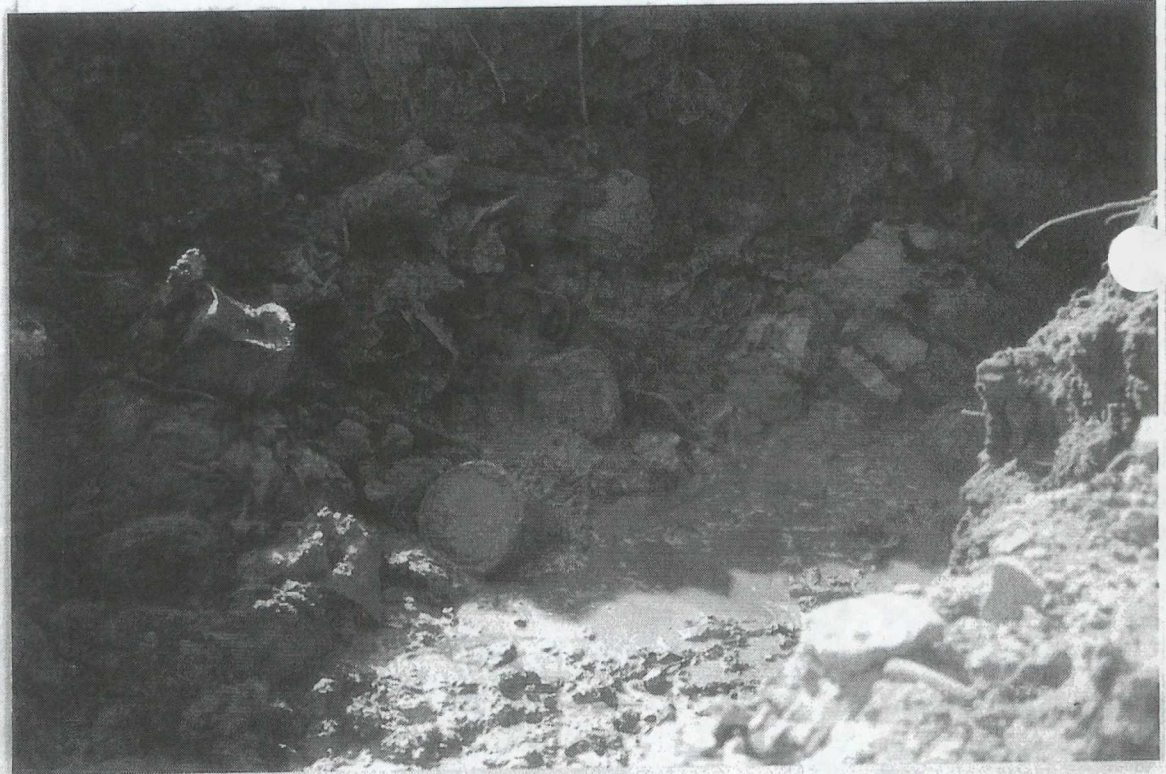
Description: This photograph shows a view of the main excavation pit. Note the buried containers and yellow discolored water.

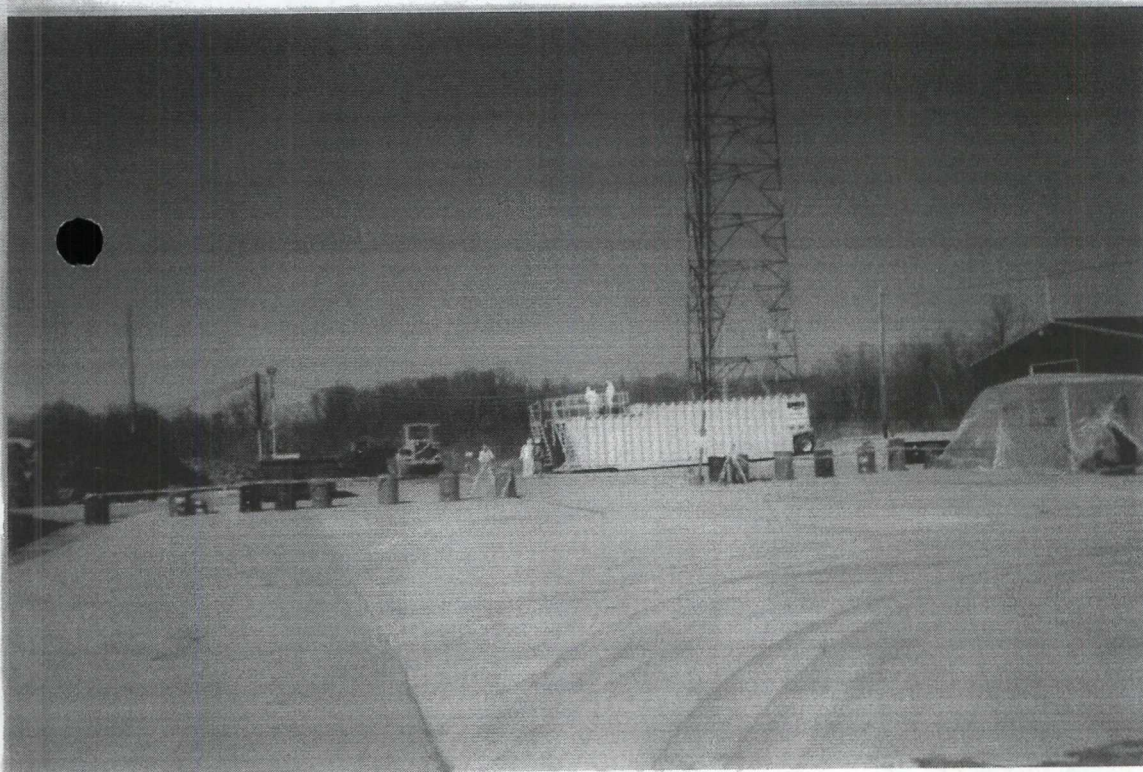
Description: This photograph show a view of two 20,000-gallon tank mobilized to site to collect the yellow discolored water.

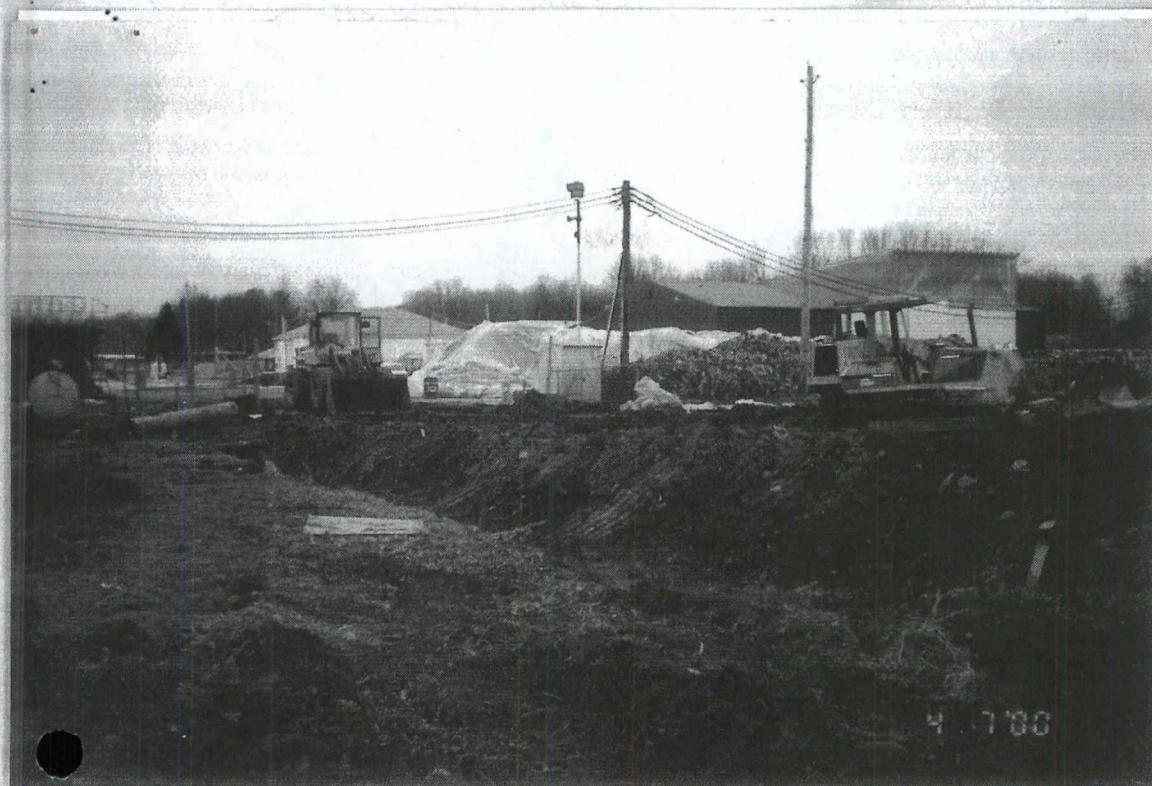
Description: This photograph shows a view of the eastern excavation area. Note the yellow discolored water and constructional debris.

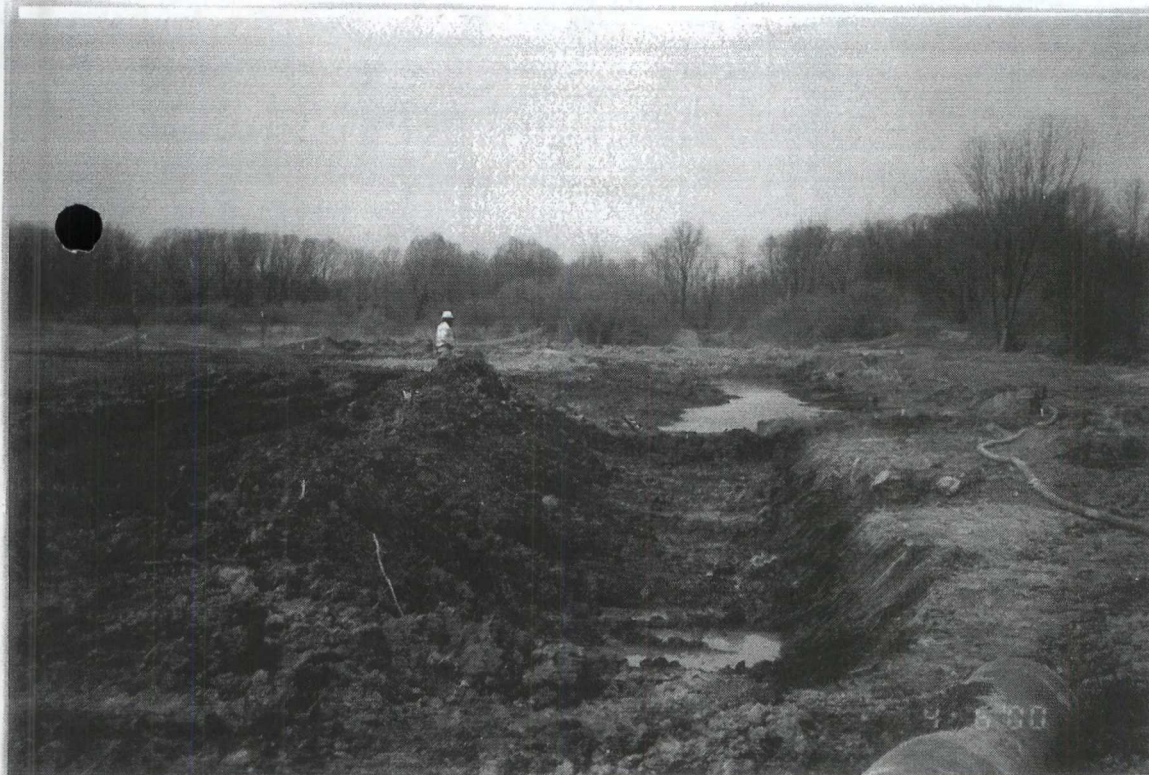
Description: This photograph shows the eastern drainage ditch, note that the southern portion has been scraped.

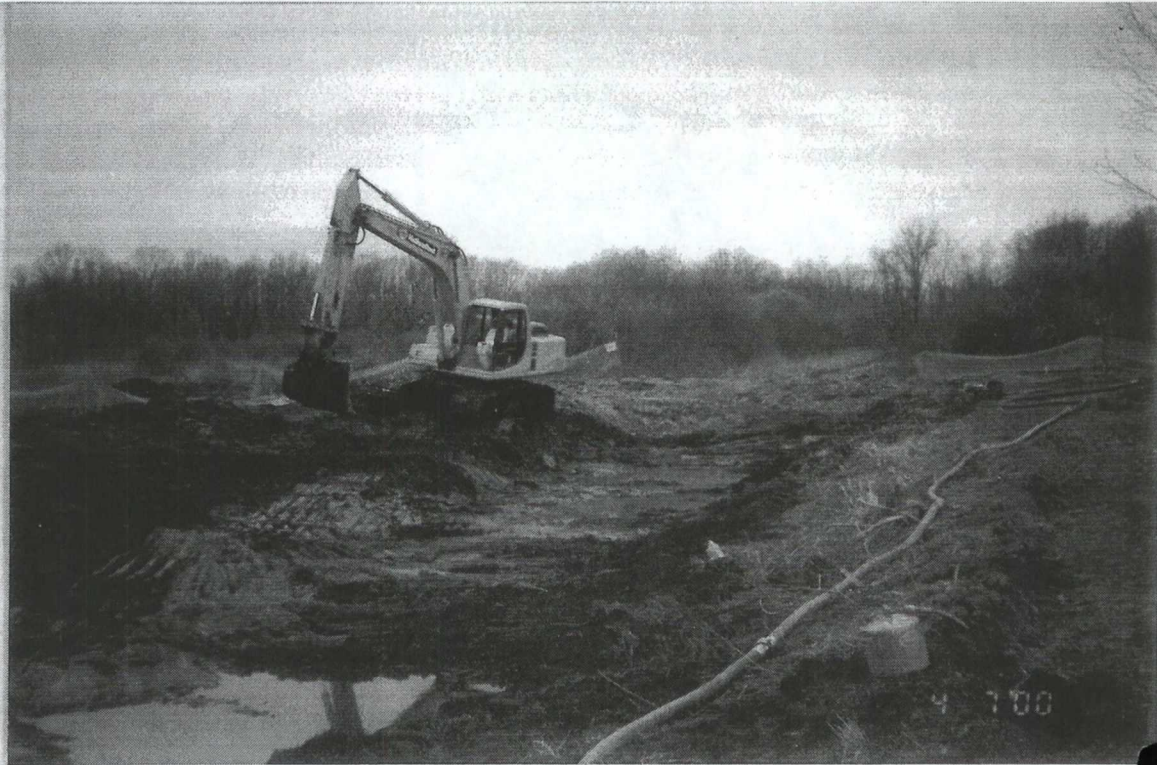
Description: This photograph shows the eastern drainage ditch, note that the northern portion has been scraped.

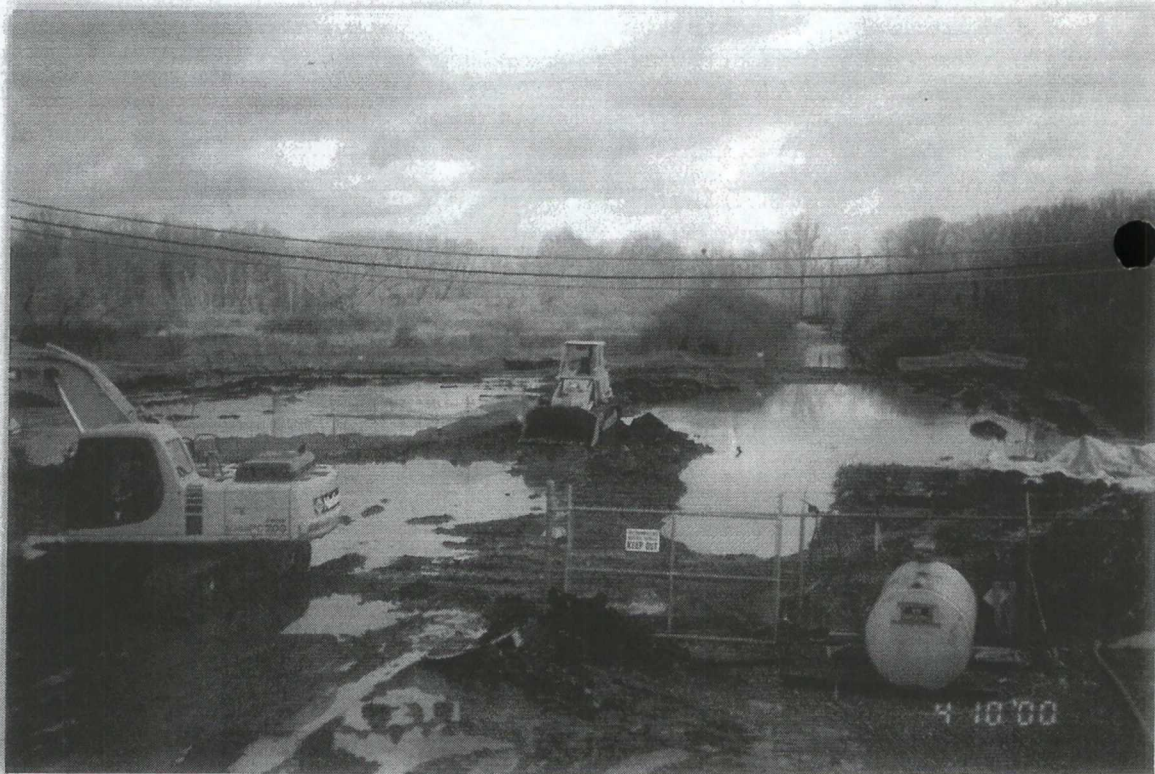
Description: This photograph shows the eastern drainage ditch after water had been pumped out and the sediments had been scraped.

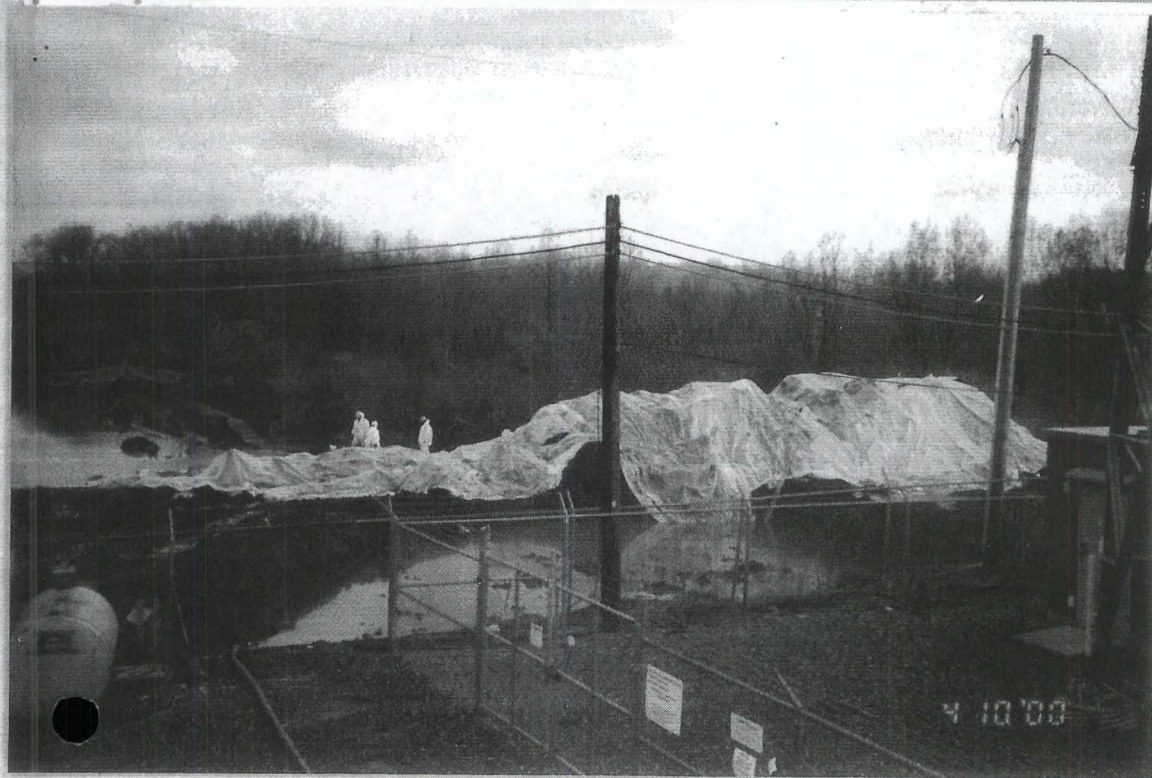
Description: This photograph shows a view of the excavation area following evening thunderstorms. Note the ERRS crew assessing flooded areas and setting up pumping stations.

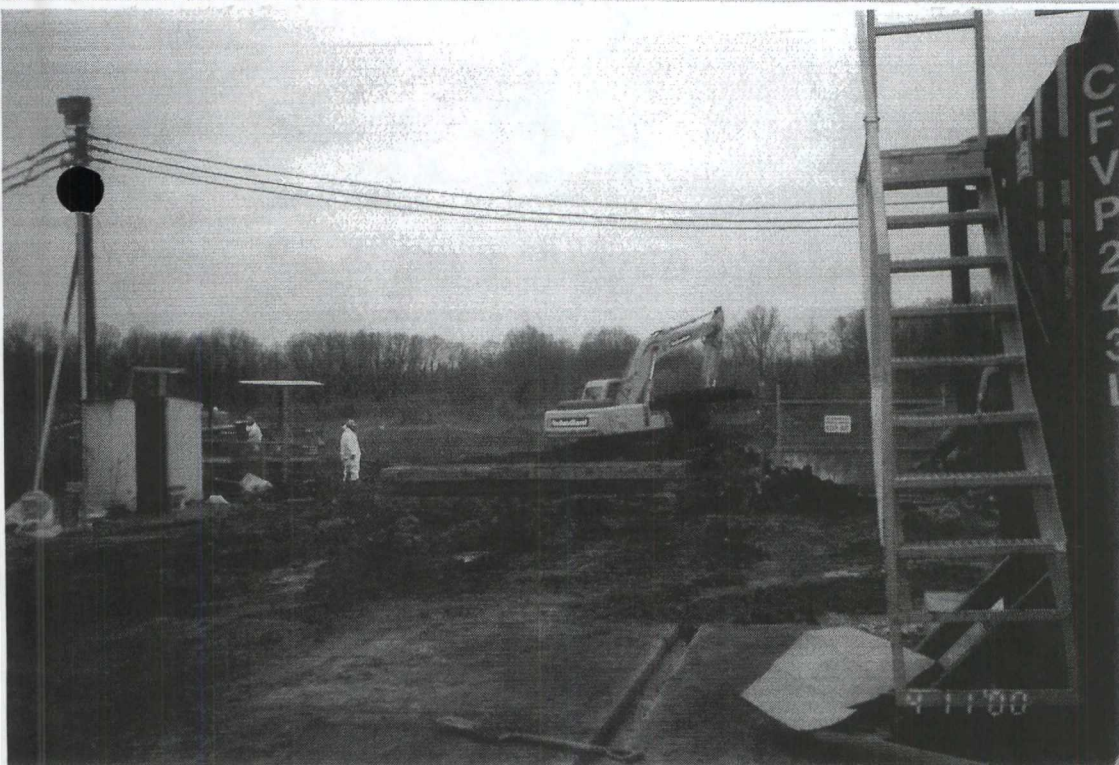
Description: ERRS mobilized swamp pads to site to enable removal activities to proceed under extremely wet conditions

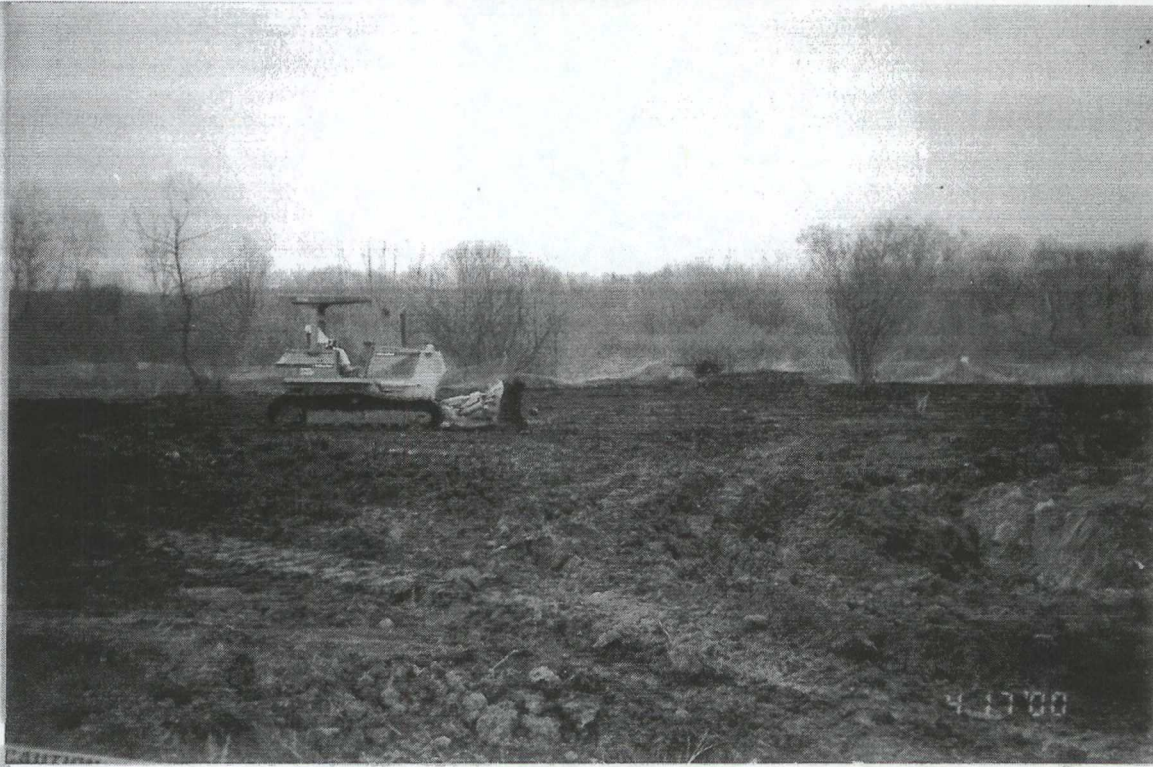
Description: This photograph shows ERRS grading the main excavation area.

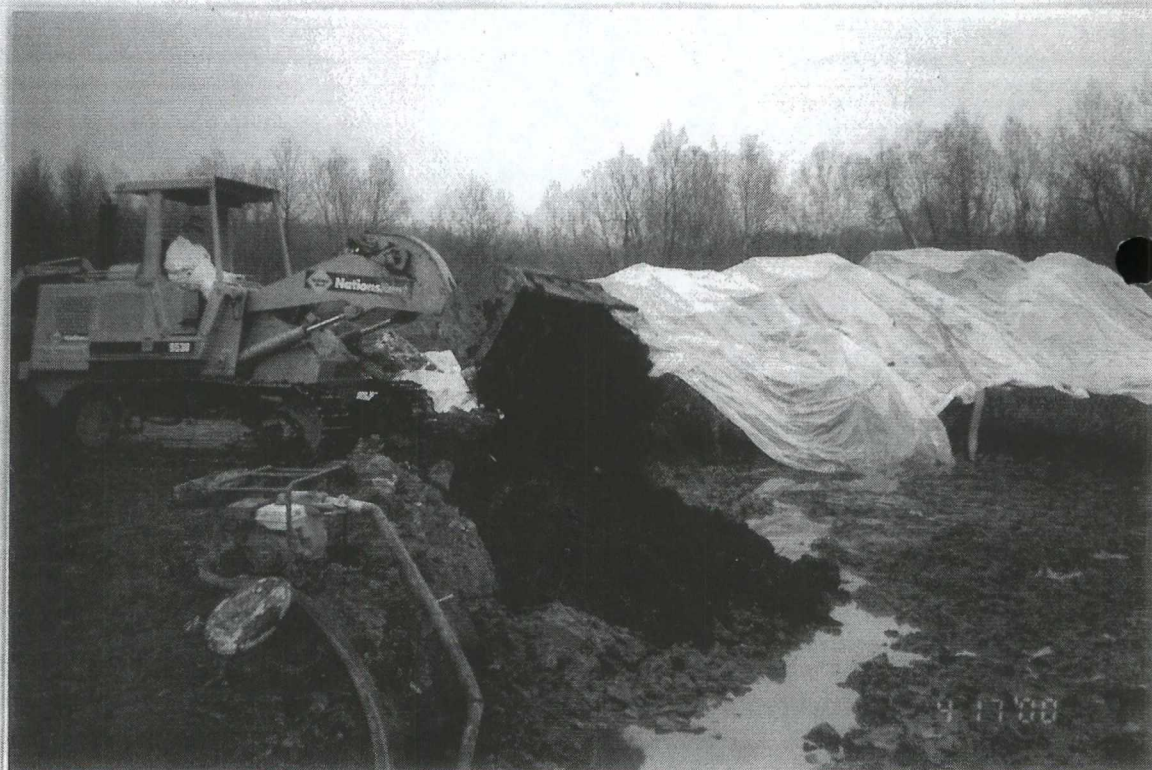
Description: This photograph shows ERRS backfilling the excavated areas.

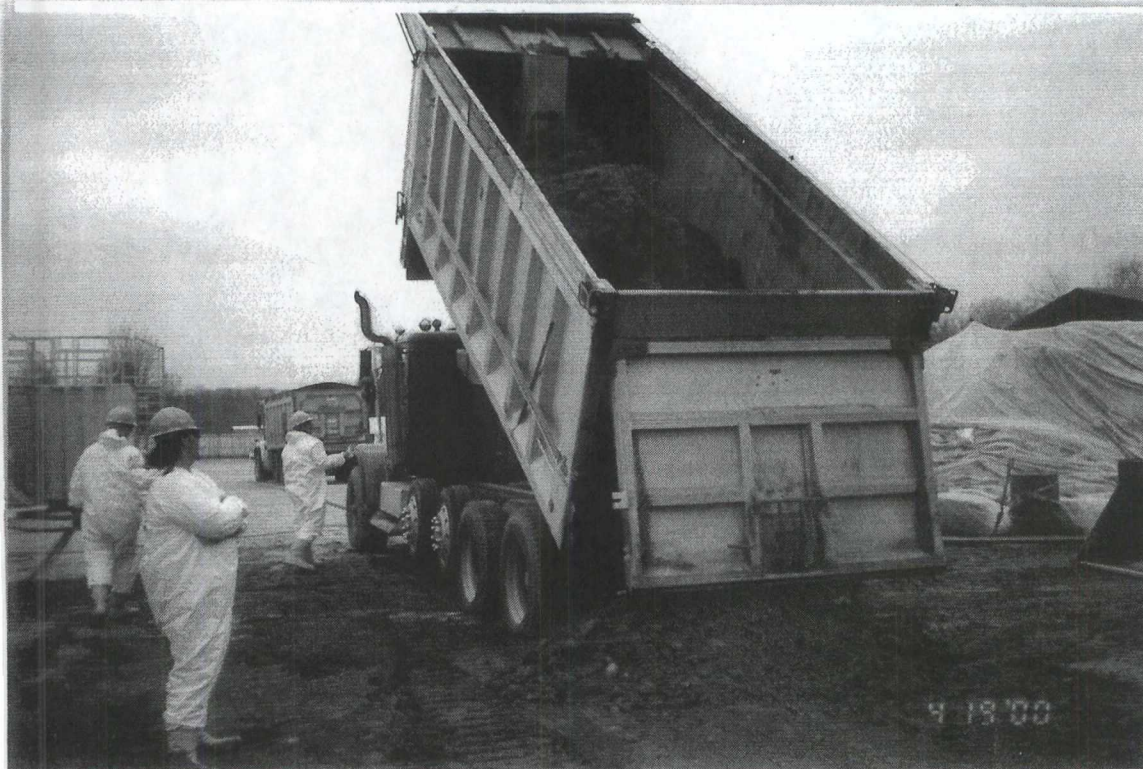
Description: Off-site clay was mobilized to site and utilized to construct a clay cap over the excavated areas.

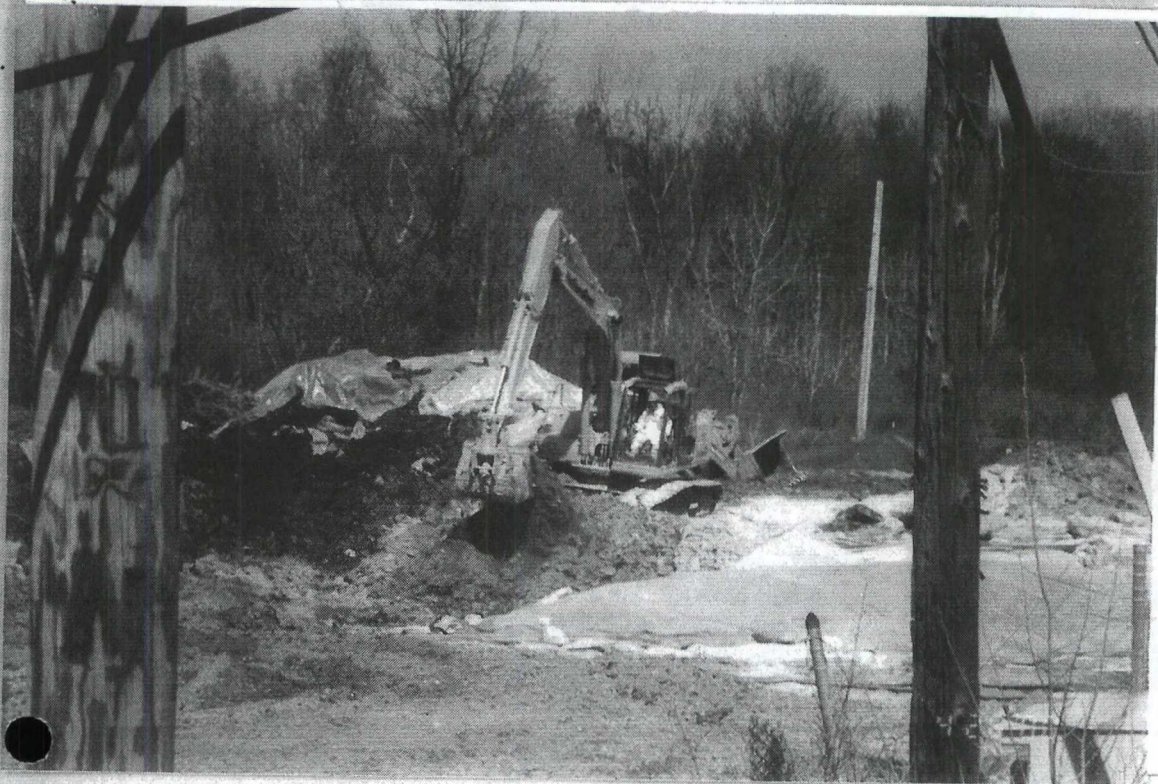
Description: This photograph shows the on-site treatment area utilized to mix lead and chromium-contaminated soil with cement kiln dust.

Excavated soil and waste were treated on site to decrease the TCLP lead and chromium concentrations to nonhazardous levels. The lime and silicates within the kiln dust react in the presence of water to solidify the soil and therefore, decreasing the leachability of the lead and chromium. The treated soil and waste were then transported off-site as non-hazardous waste to be landfilled. Water collected on site was transported off-site for recycling. Table 6 contains specific disposal information for all waste streams.
